# Manhole Inspection Summary

Manhole # S49GG\_020MH

**Inspection** ☐ Is Incomplete Rating: **3) Fair**

Insp Date: **8/7/08 10:34 AM**

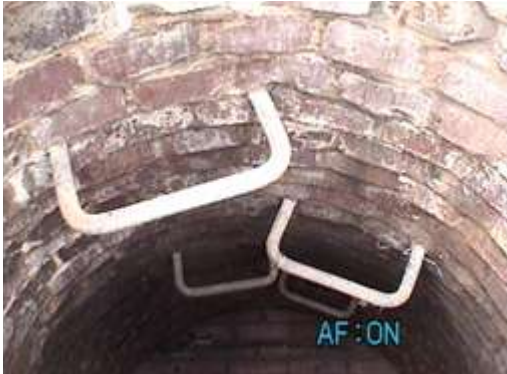
Defect 2

Infiltration: ☐ None ☐ Joint ☐ Cracks ☐ Mortar ☐ Roots ☒ **Wall**

Infiltration

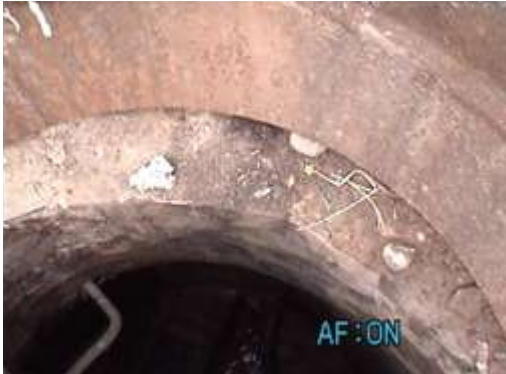
Defect 1

frame leaks

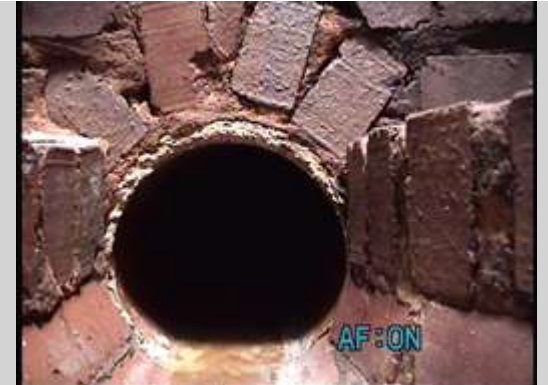
12 O'Clock Outflow

8 in. Circular Gravity Sewer  
Pipe Out @ 12 O'Clock

Pipe Height: **8.4** (in.) Rod and Bar (Angled)  
Pipe Material: **Clay** ☐ Pipe Lined  
Invert Depth: **8.50** (ft.) Flow Characteristics: **Fast**  
Deposits: ☒ None ☐ Mud ☐ Sludge ☐ Debris ☐ Grease  
Silt Depth: (in.) Deposits Extent:  
Infiltration: **None** Pipe Seal Cond: **Sound**

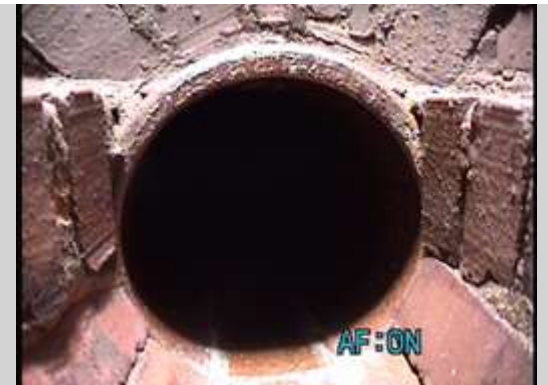
3 O'Clock Inflow

8 in. Circular Gravity Sewer  
Pipe In @ 3 O'Clock

Pipe Height: **8.4** (in.) Rod and Bar (Angled)  
Pipe Material: **Clay** ☐ Pipe Lined  
Invert Depth: **8.30** (ft.) Flow Characteristics: **Fast**  
Deposits: ☒ None ☐ Mud ☐ Sludge ☐ Debris ☐ Grease  
Silt Depth: (in.) Deposits Extent:  
Infiltration: **None** Pipe Seal Cond: **Sound**

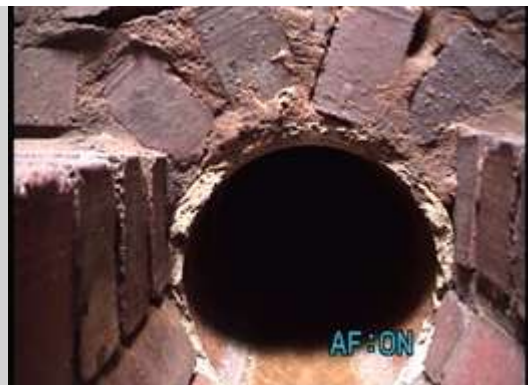
6 O'Clock Inflow

Infiltration: **None** Pipe Seal Cond: **Sound**
